**NASA TECHNICAL
MEMORANDUM**

NASA TM X-3494

**NASA AVIATION SAFETY REPORTING SYSTEM:
SECOND QUARTERLY REPORT
JULY 15-OCTOBER 14, 1976**

*Ames Research Center
Moffett Field, Calif. 94035*

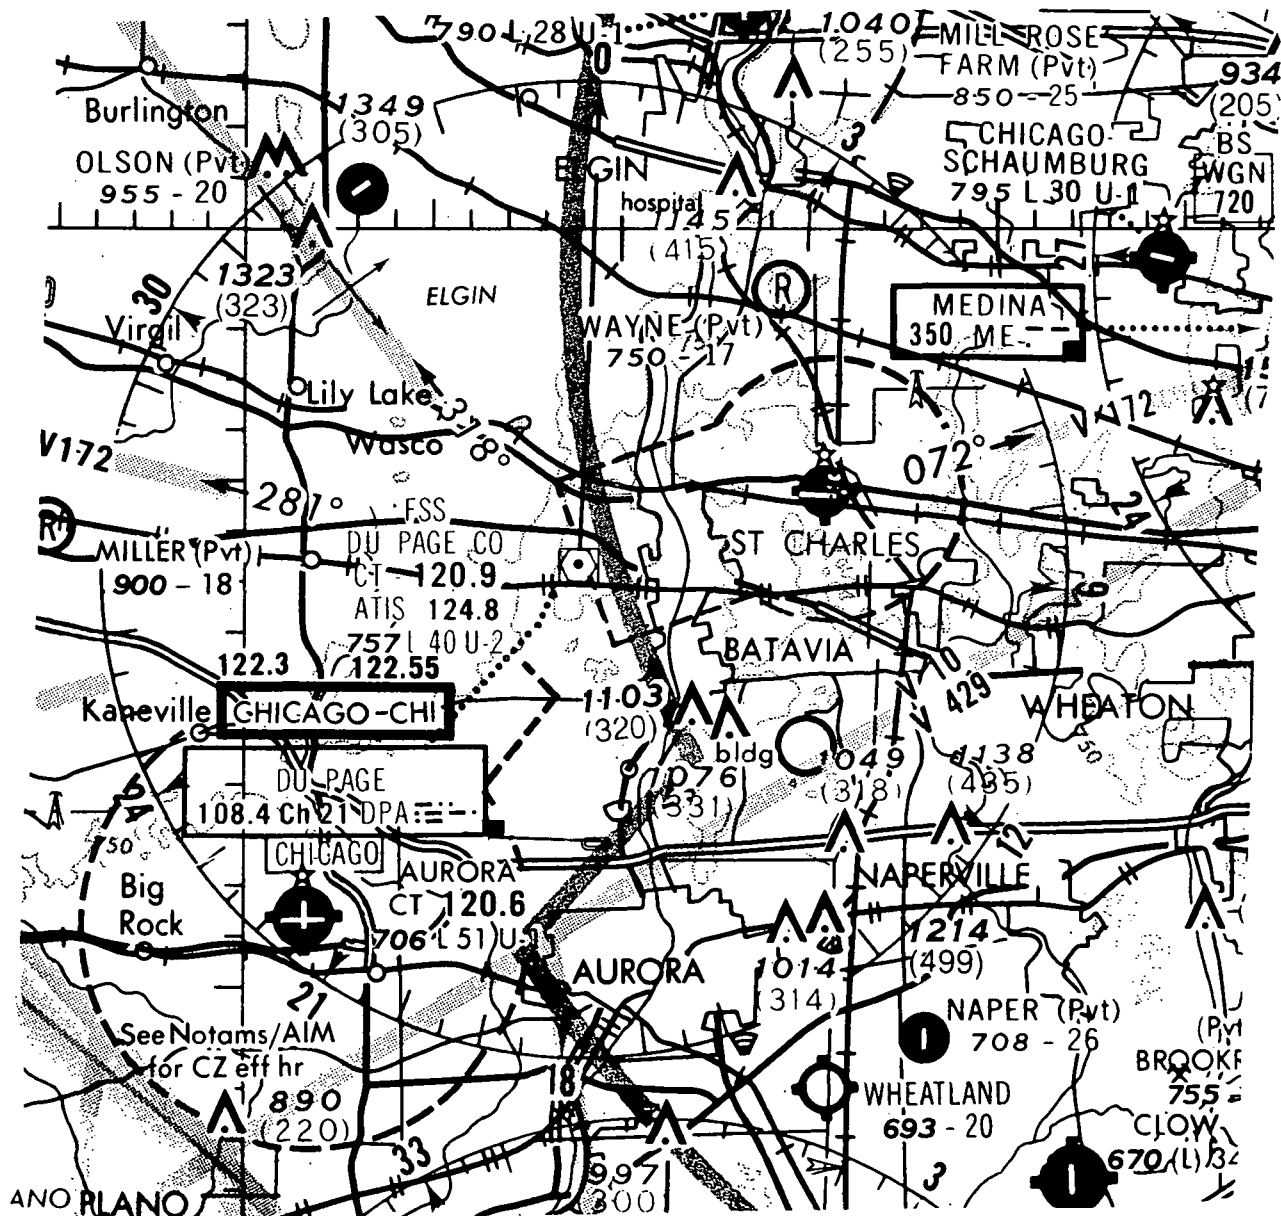
Figure 6.— Chicago sectional chart.

be placed where DuPage Apt info is, and that DuPage Apt info be located between Elgin intxn and Wayne Apt. Subsequent pilot report verifies the problem; pilot landed at DuPage without contacting Twr, due to difficulty in interpreting chart while trying to avoid severe weather.

Text of Response: The National Ocean Survey (NOS) has been notified of this confusing situation and they have advised that it will be corrected in later issue of the Chicago Sectional (fig. 6).

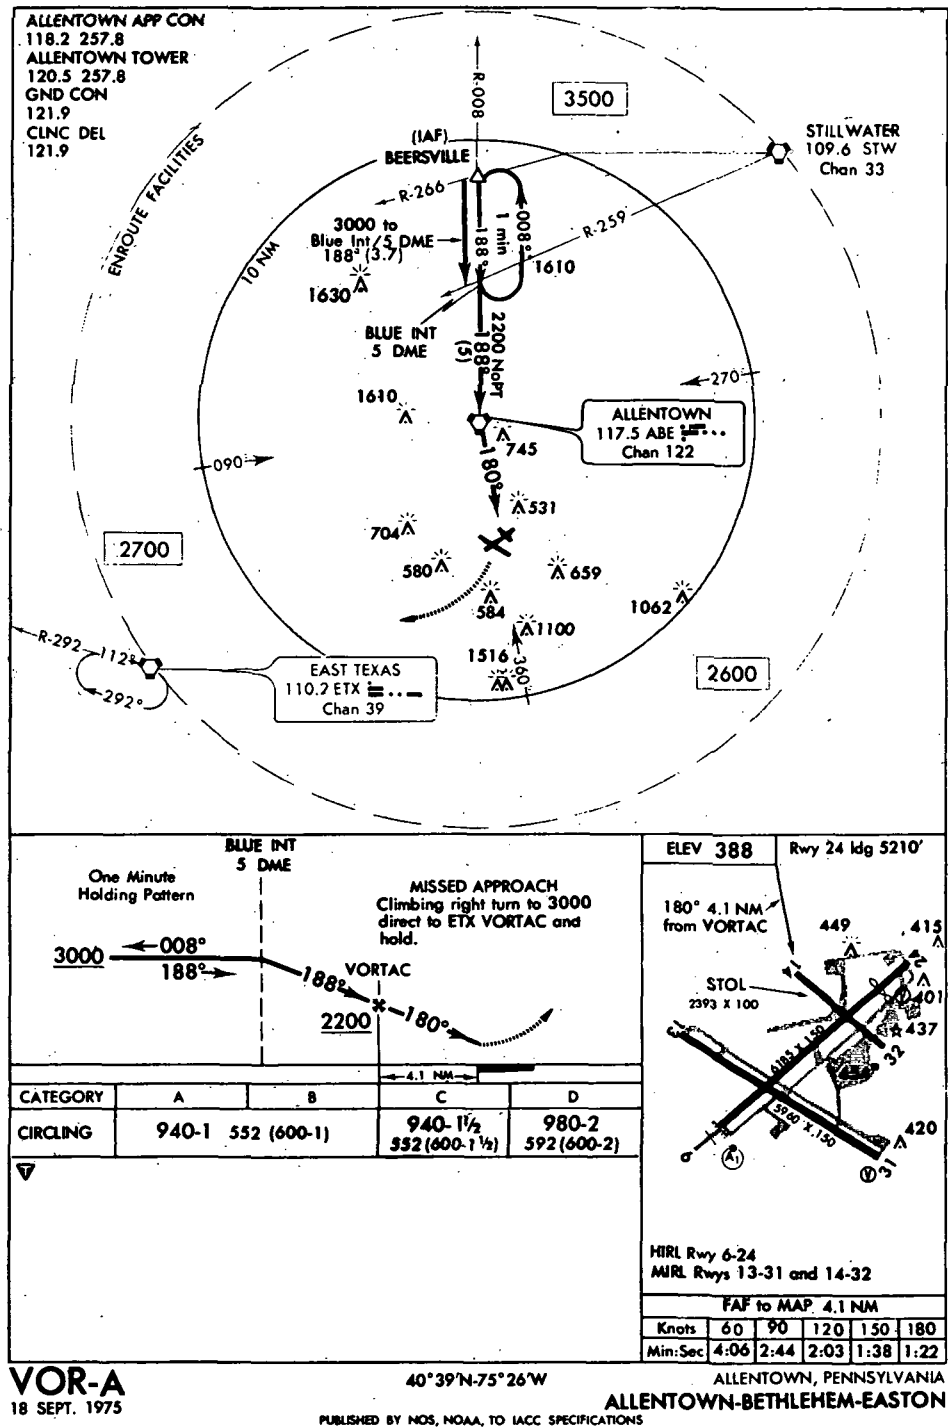
Figure 8.— Approach chart AL-15.

This problem was discovered by observing several aircraft that when executing the VOR-A approach via own navigation to VOR then procedure turn which should start at the Blue intersection (5 nautical miles North of ABE VOR) but were, still are in fact, proceeding outbound to Beersville intersection (20 nautical miles North of ABE VOR) and commencing a procedure turn from Beersville intersection. Approach altitude from Beersville to Blue intersection is 3000 ft. Sector altitude north of Beersville becomes 3500 ft. By the approach plate, procedure turn altitude is 3000 ft. If a procedure turn is executed from Beersville with maneuvering north and east (which is incorrect) the aircraft in many cases entered the 3500 ft sector altitude area. This could be hazardous. In recent days over half of the aircraft that I have worked making this approach have conducted the approach incorrectly. Upon advising the pilots of the observed deviation they seem to see the mistake right away. It is my belief that the approach plate (AL-15) is misleading pilots to

make the procedure turn mistake. Blue intersection is poorly depicted on the chart. This approach plate needs review. (Fig. 8 illustrates this report.)
